**Newell Porcelain Cleanup Application – 11.2.17 DRAFT
The Narrative Proposal/Ranking Criteria**

FORMER NEWELL PORCELAIN FACILITY
FIFTH & HARRISON STREETS
NEWELL, WEST VIRGINIA
(HANCOCK COUNTY)

ASBESTOS SURVEY REPORT

MID ATLANTIC JOB NUMBER: CEC-17-20

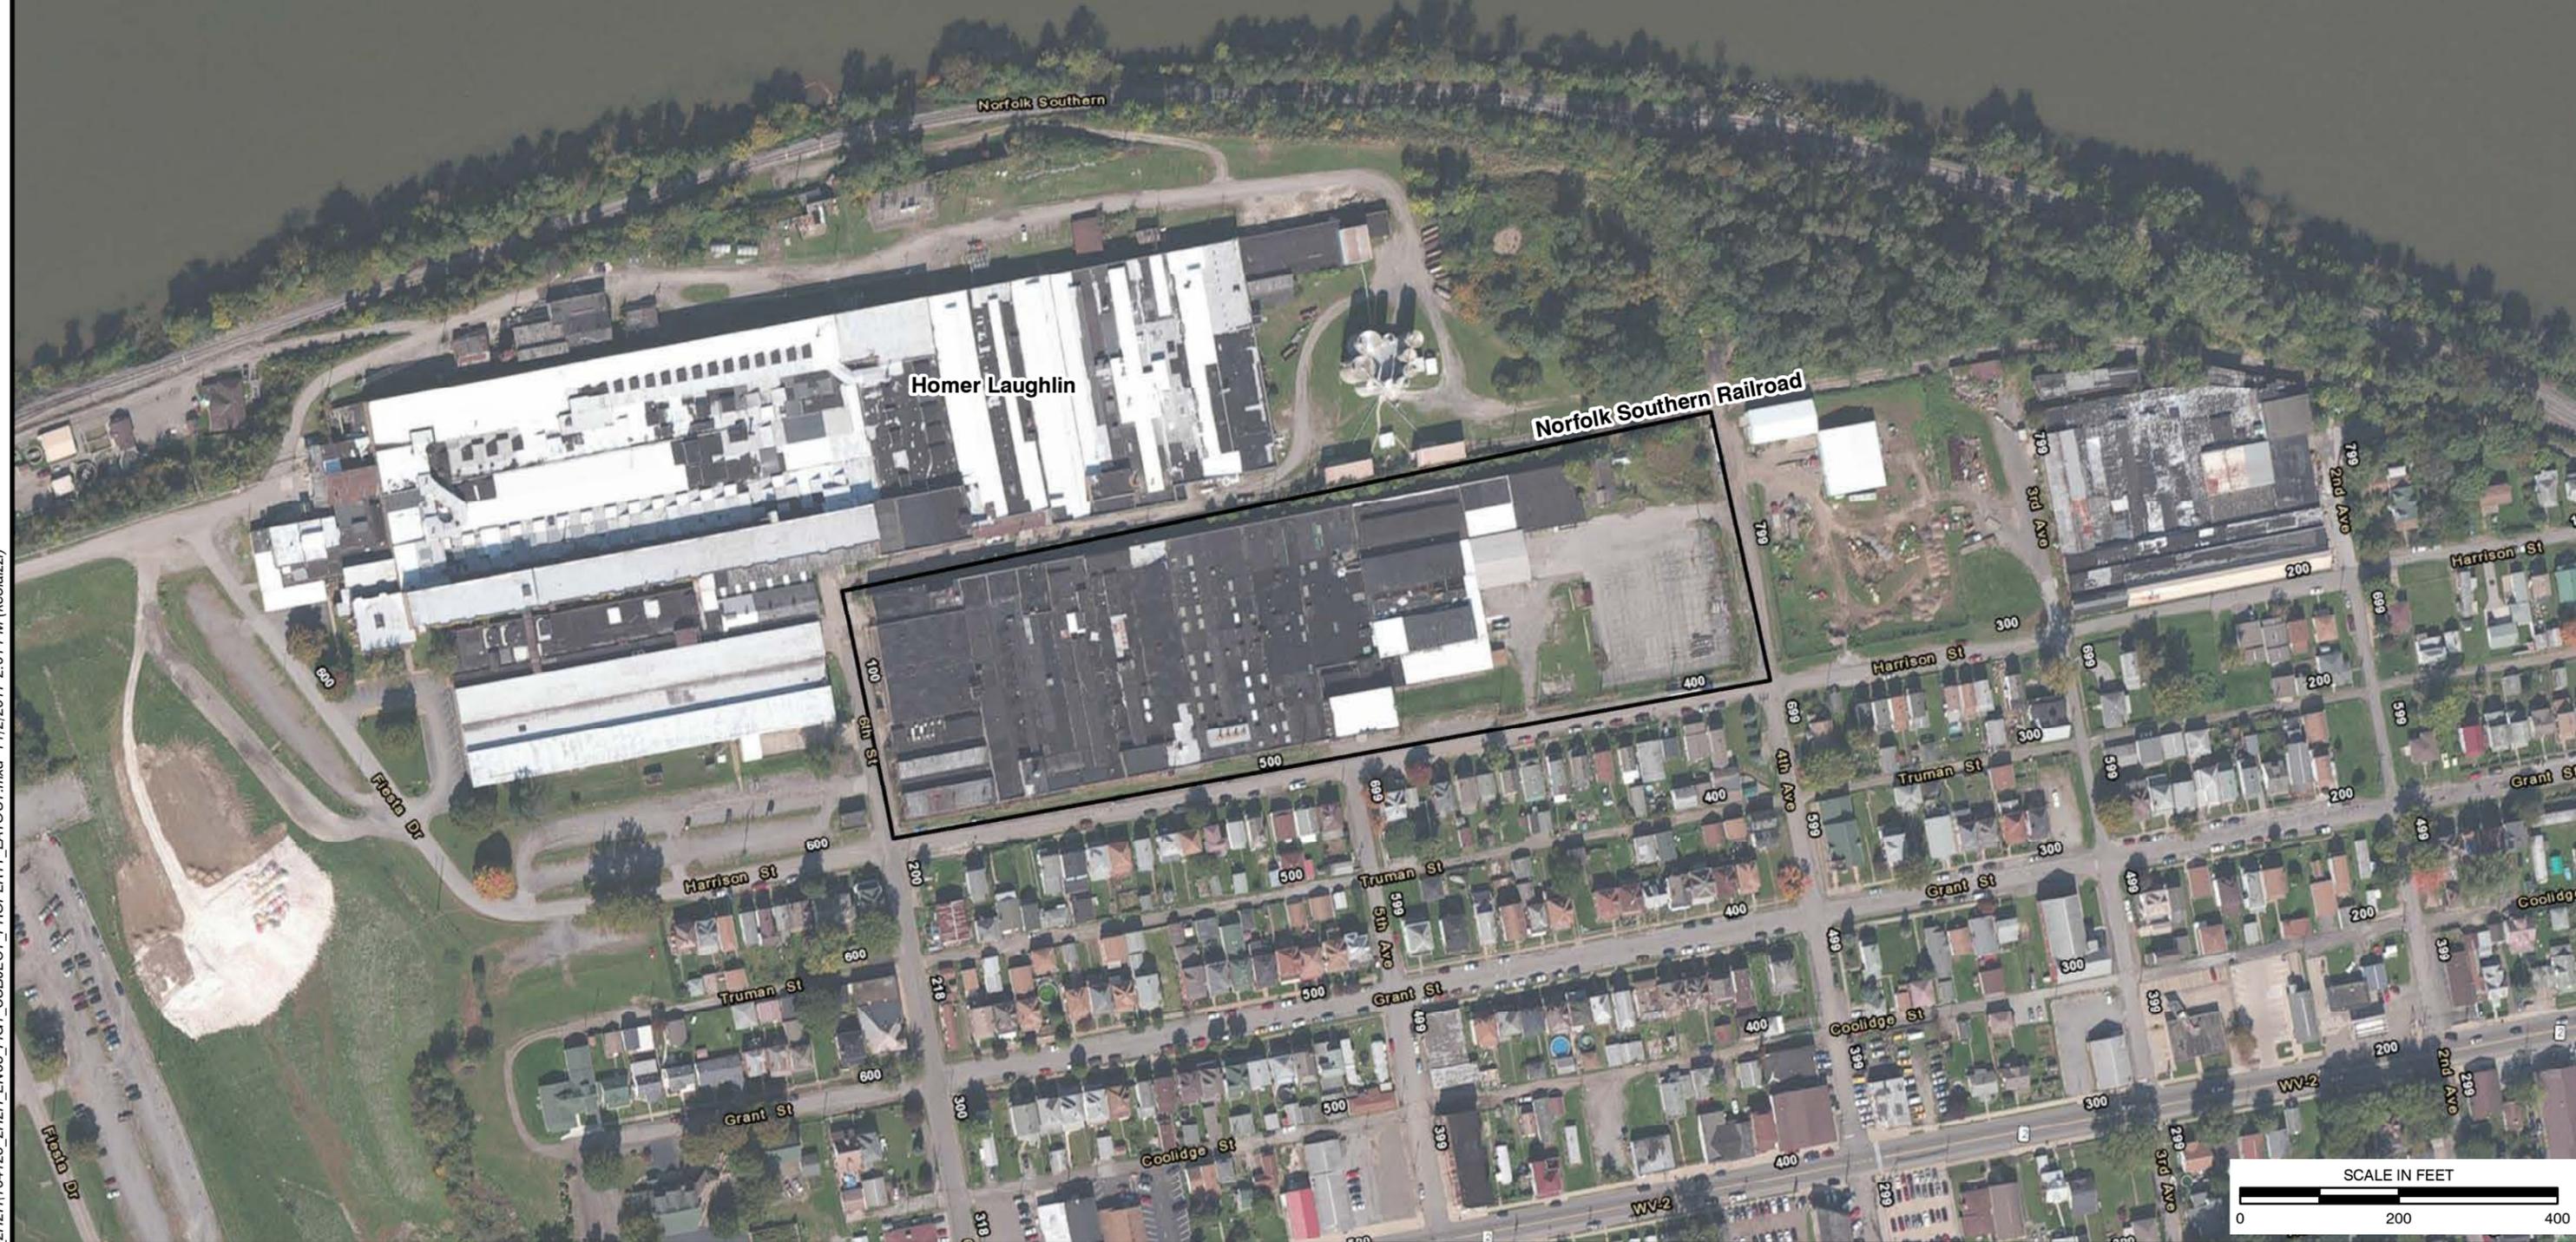
The Site covers approximately 8 acres and is located along at Fifth and Harrison Streets in the City of Newell, Hancock County, West Virginia. The majority of the Site covered by buildings or pavement. The main manufacturing building, much of which is deteriorated and determined to be structurally unsound, covers approximately 5.9 acres. Three smaller buildings situated on concrete slab-on-grade foundations are located near the northeastern corner of the Site. These include the Frit House building, the Gas House, and the Pump House. The Site is located in a mixed-use area consisting of commercial, industrial and residential properties. The Site layout is shown on Figure 1.

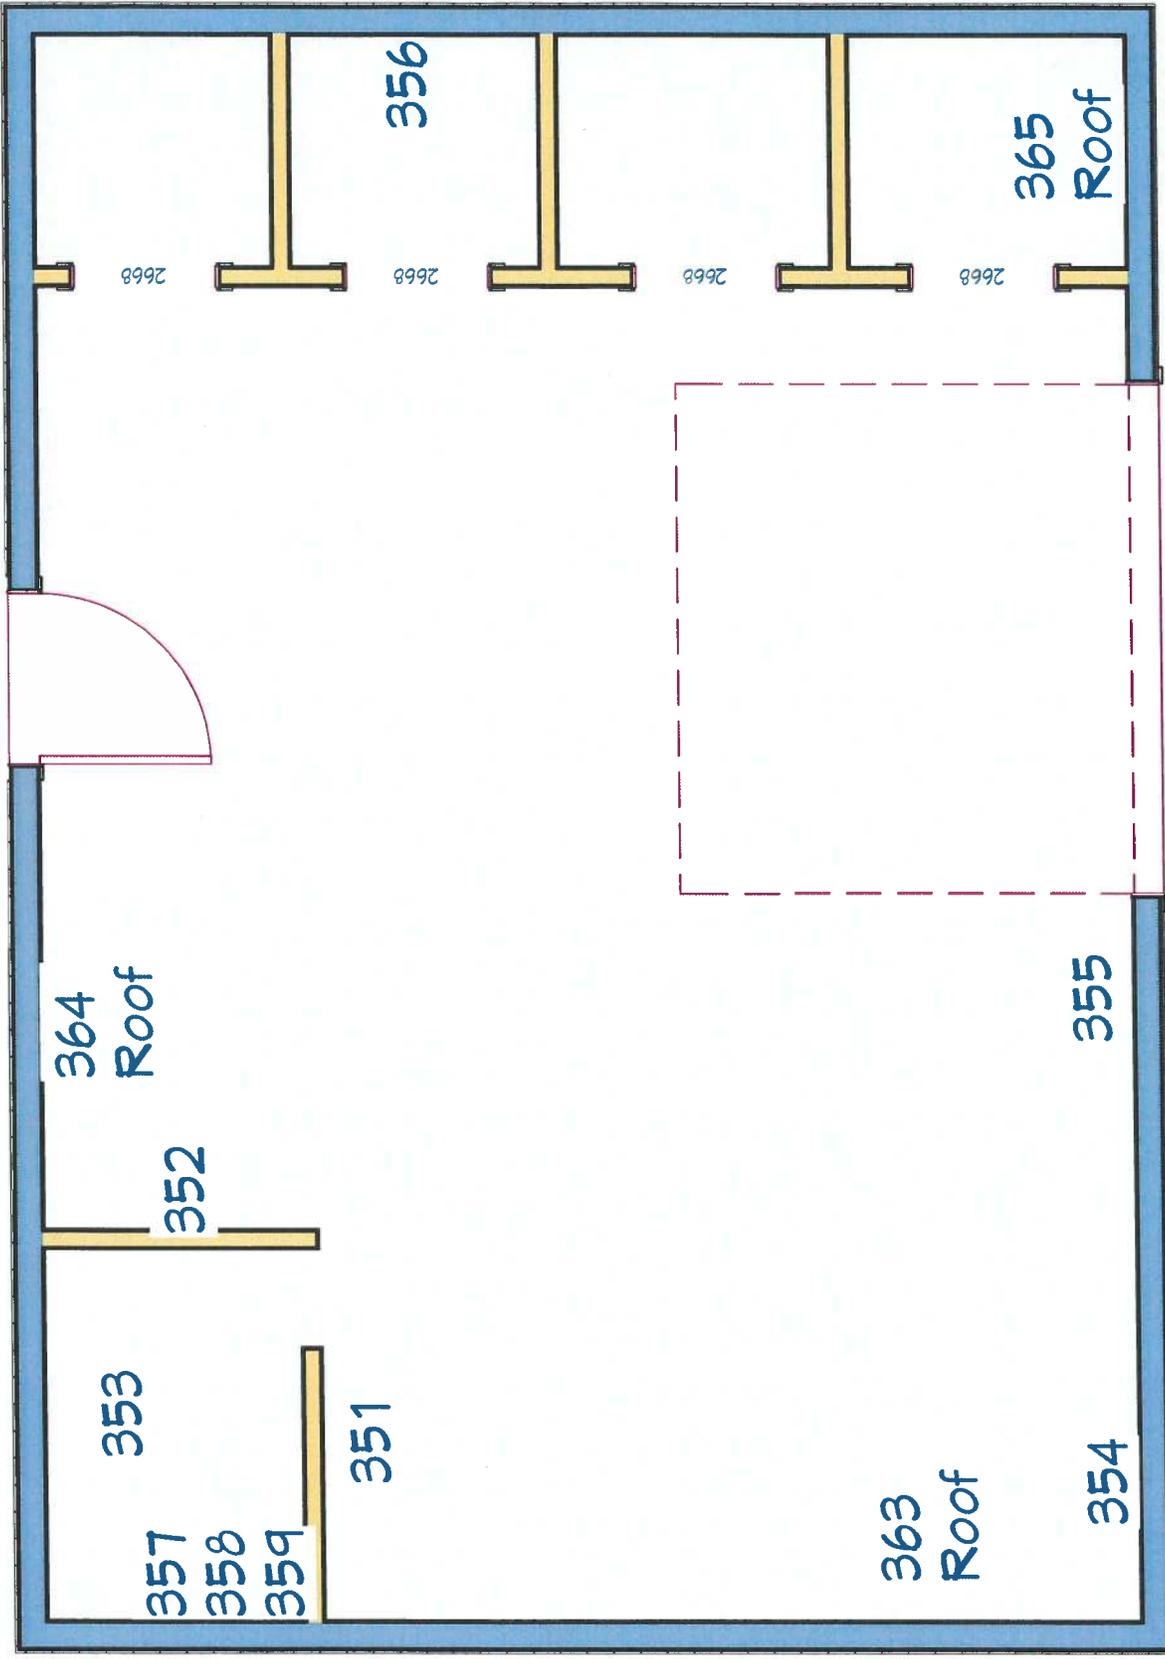
South Basement

- The basement area, located in the center of the facility, was inaccessible due to the floor and the steps being collapsed / caved in. Roofing materials / debris was found in this area as well due to the roof being collapsed.

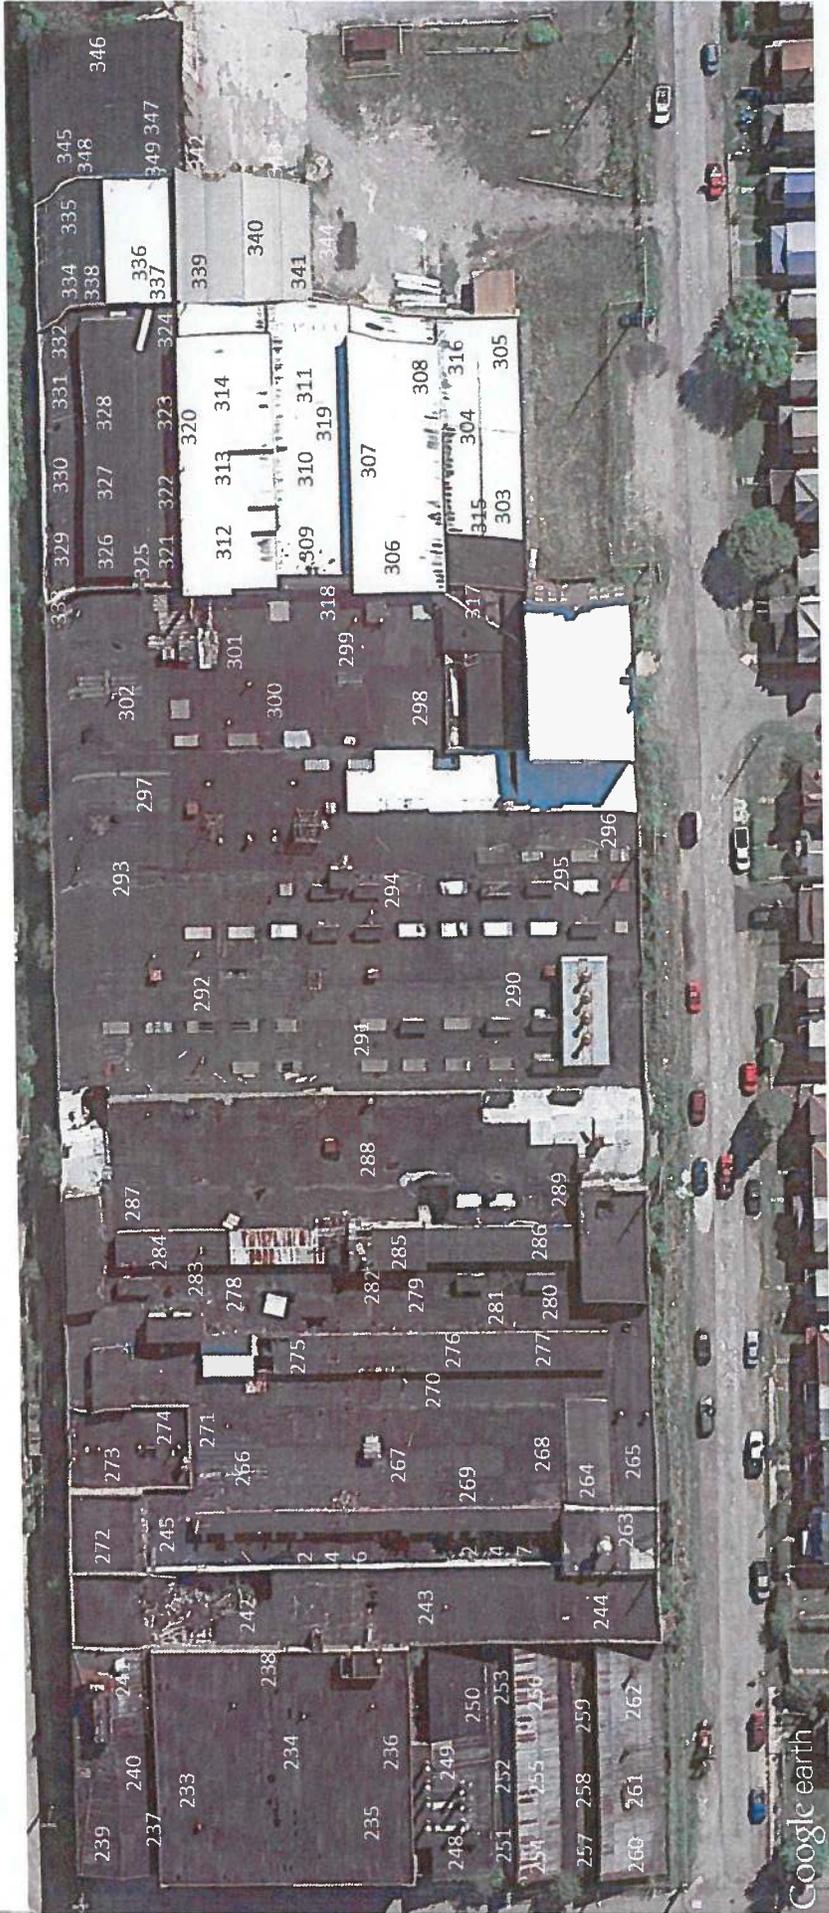
Newell Porcelain Plant Roofs

- Roofs and floors were collapsed in various areas throughout the facility.
- Facility rooftops were found to be structurally unsound during our on-site investigation. MAEC survey personnel sampled accessible roofing materials from collapsed areas and holes within the plant. All roofs were surveyed with the exception of the Office Building roof as per the direction of the current site owner Haydall Redevelopment, LLC. The Office Building roof / associated flashing is assumed to be asbestos containing and must be treated as such if demolition procedures are implemented.
