Weirton Steel FY18 Brownfield Cleanup Grant Application

The following application will be updated and submitted as two separate EPA Cleanup Grant Applications. The applications together will request funding for the cleanup asbestos that has been located in 6 structures on Main Street in Weirton, spanning north of the Open Hearth Building.

MINGO JUNCTION STEEL WORKS
NORTH END BUILDINGS
BOTTOM STOVE BUILDING
WEIRTON, WEST VIRGINIA
(HANCOCK COUNTY)

ASBESTOS SURVEY REPORT

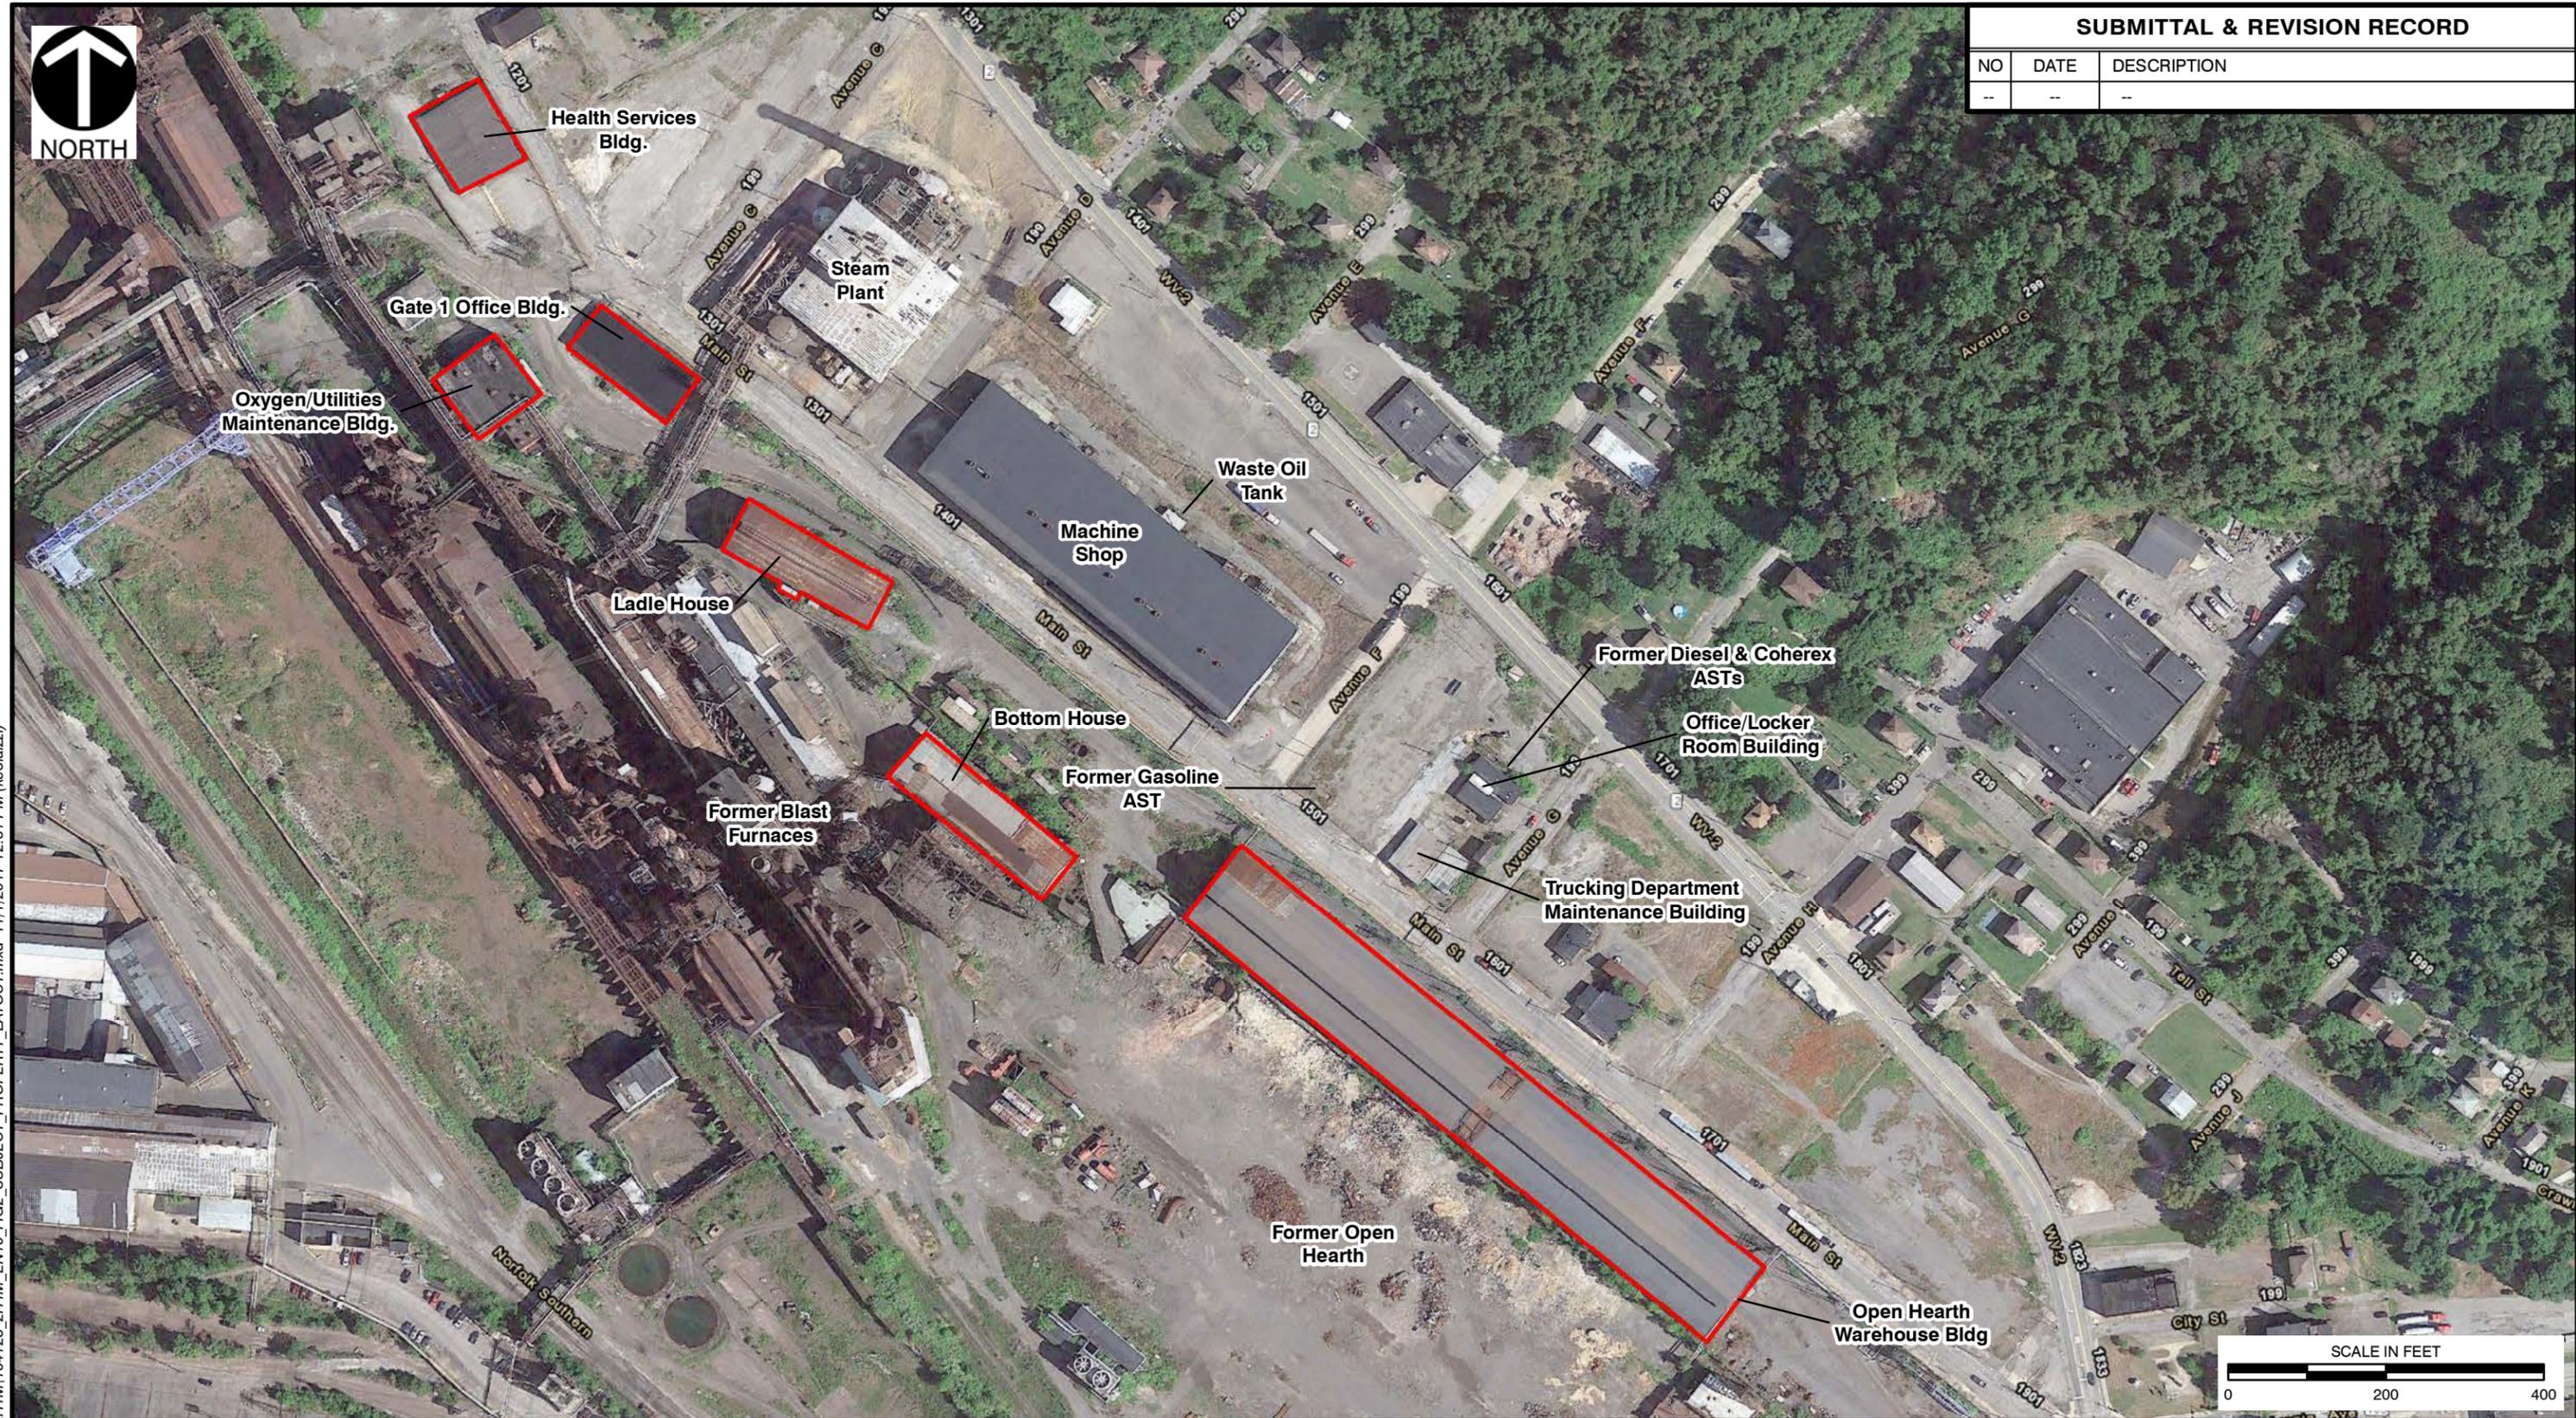
The Site covers approximately 0.38 acres and is located along North Main Street in the City of Weirton, Hancock County, West Virginia. The Site contains the former Bottom House, a 16,500 square foot steel-framed and sided structure with concrete foundations and floors. The Site is located in a mixed-use area consisting of commercial, industrial and residential properties. The Site layout is shown on Figure 1.

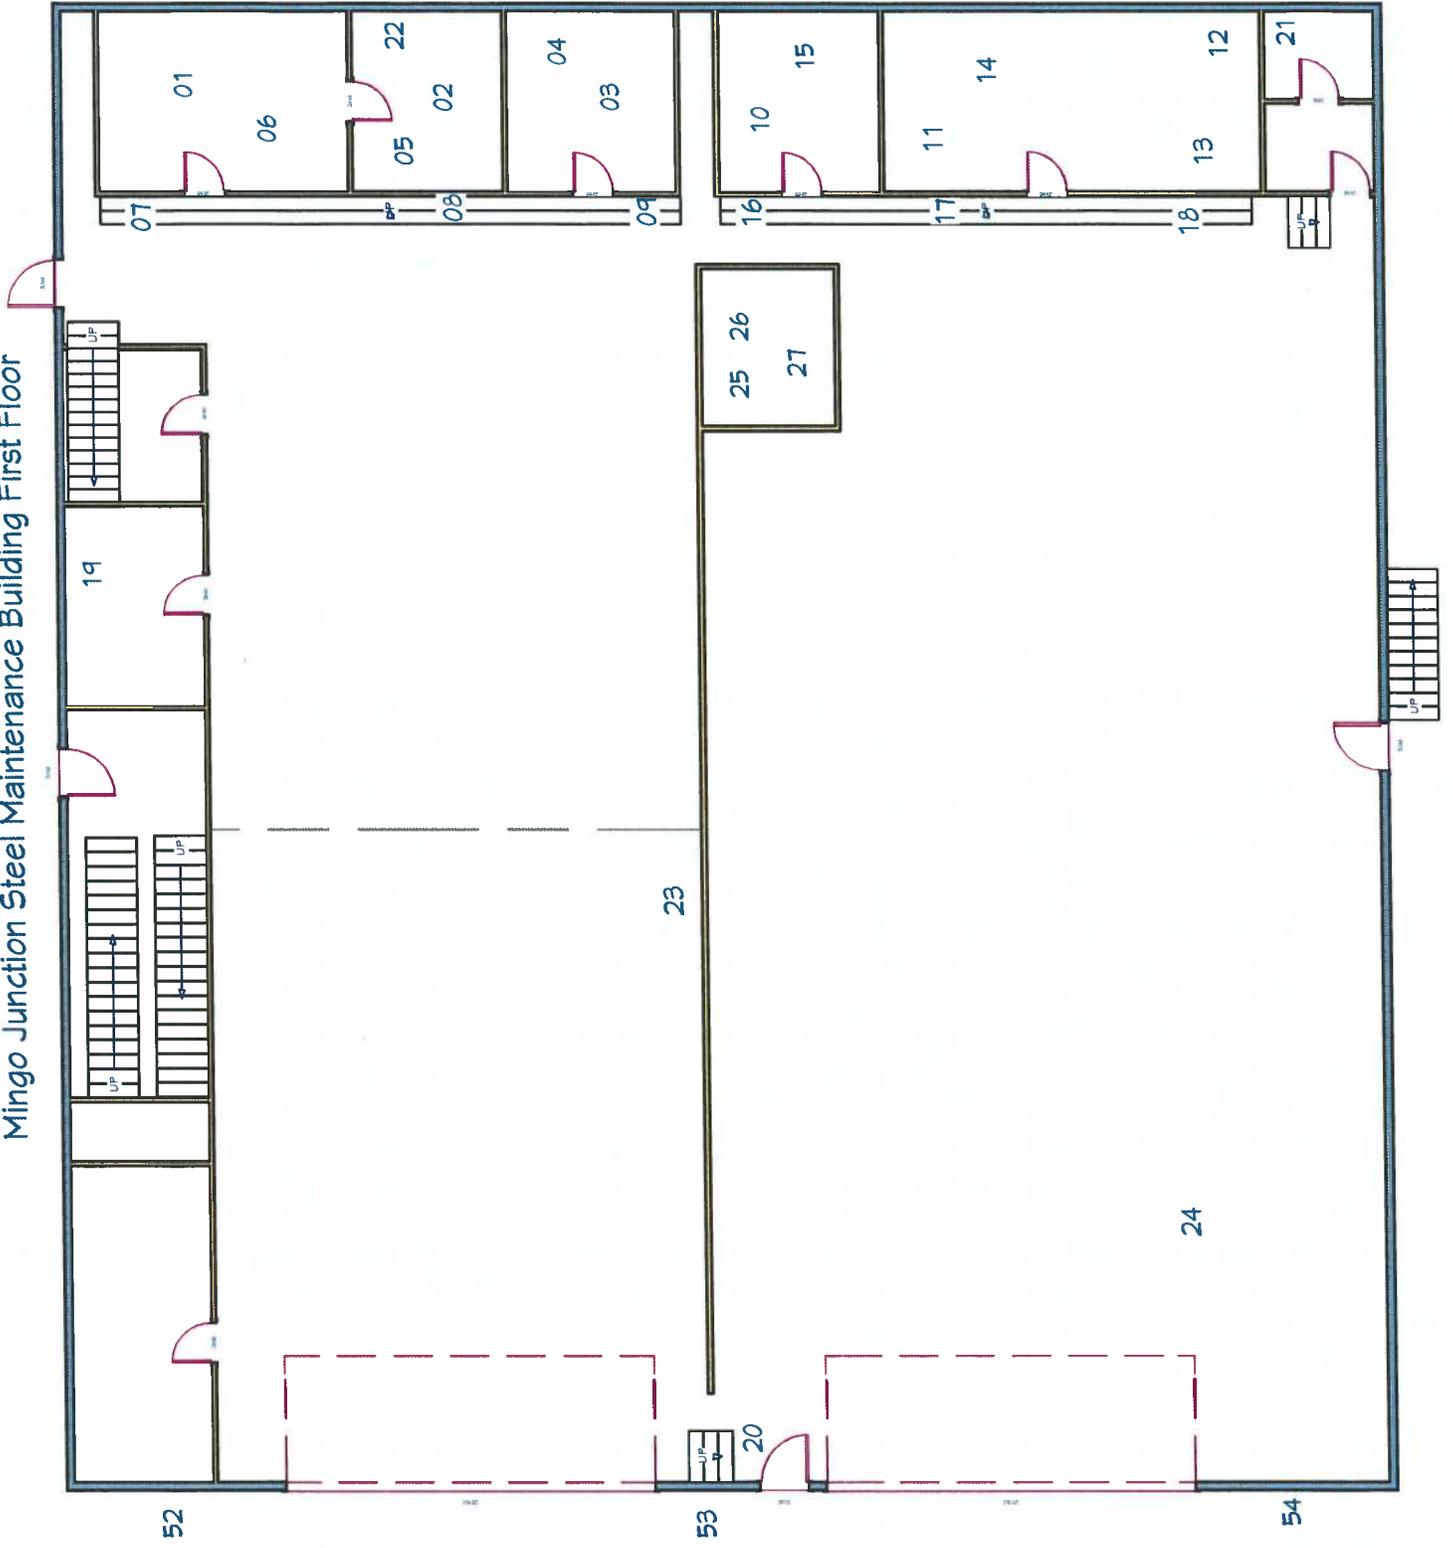
Mingo Junction Steel Maintenance Building First Floor

SAMPLE	LOCATION	DESCRIPTION	APPROX QUANTITY	CONDITION	POTENTIAL FOR DAMAGE	ASBESTOS CONTENT
22	Maintenance Building 1 st Floor Labeled Asbestos Blue Painted 12" Pipe	White Insulation	200 Ln Ft Visible (H)	Poor	High	50 %
23	Maintenance Building 1 st Floor Labeled Asbestos Blue Painted 12" Pipe	White Insulation	(H)	Poor	High	50 %
24	Maintenance Building 1 st Floor Labeled Asbestos Blue Painted 12" Pipe	White Insulation	(H)	Poor	High	50 %
25	Maintenance Building 1 st Floor Break Room	Tan 12 x 12 Floor Tile	200 Sq Ft (I)	Poor	High	None
26	Maintenance Building 1 st Floor Break Room	Tan 12 x 12 Floor Tile	(I)	Poor	High	None
27	Maintenance Building 1 st Floor Break Room	Tan 12 x 12 Floor Tile	(I)	Poor	High	None
28	Maintenance Building Basement Electrical Room In Electrical Boxes	Grey Transite	100 Sq Ft (J)	Poor	High	25 %
29	Maintenance Building Basement Electrical Room In Electrical Boxes	Grey Transite	(J)	Poor	High	25 %

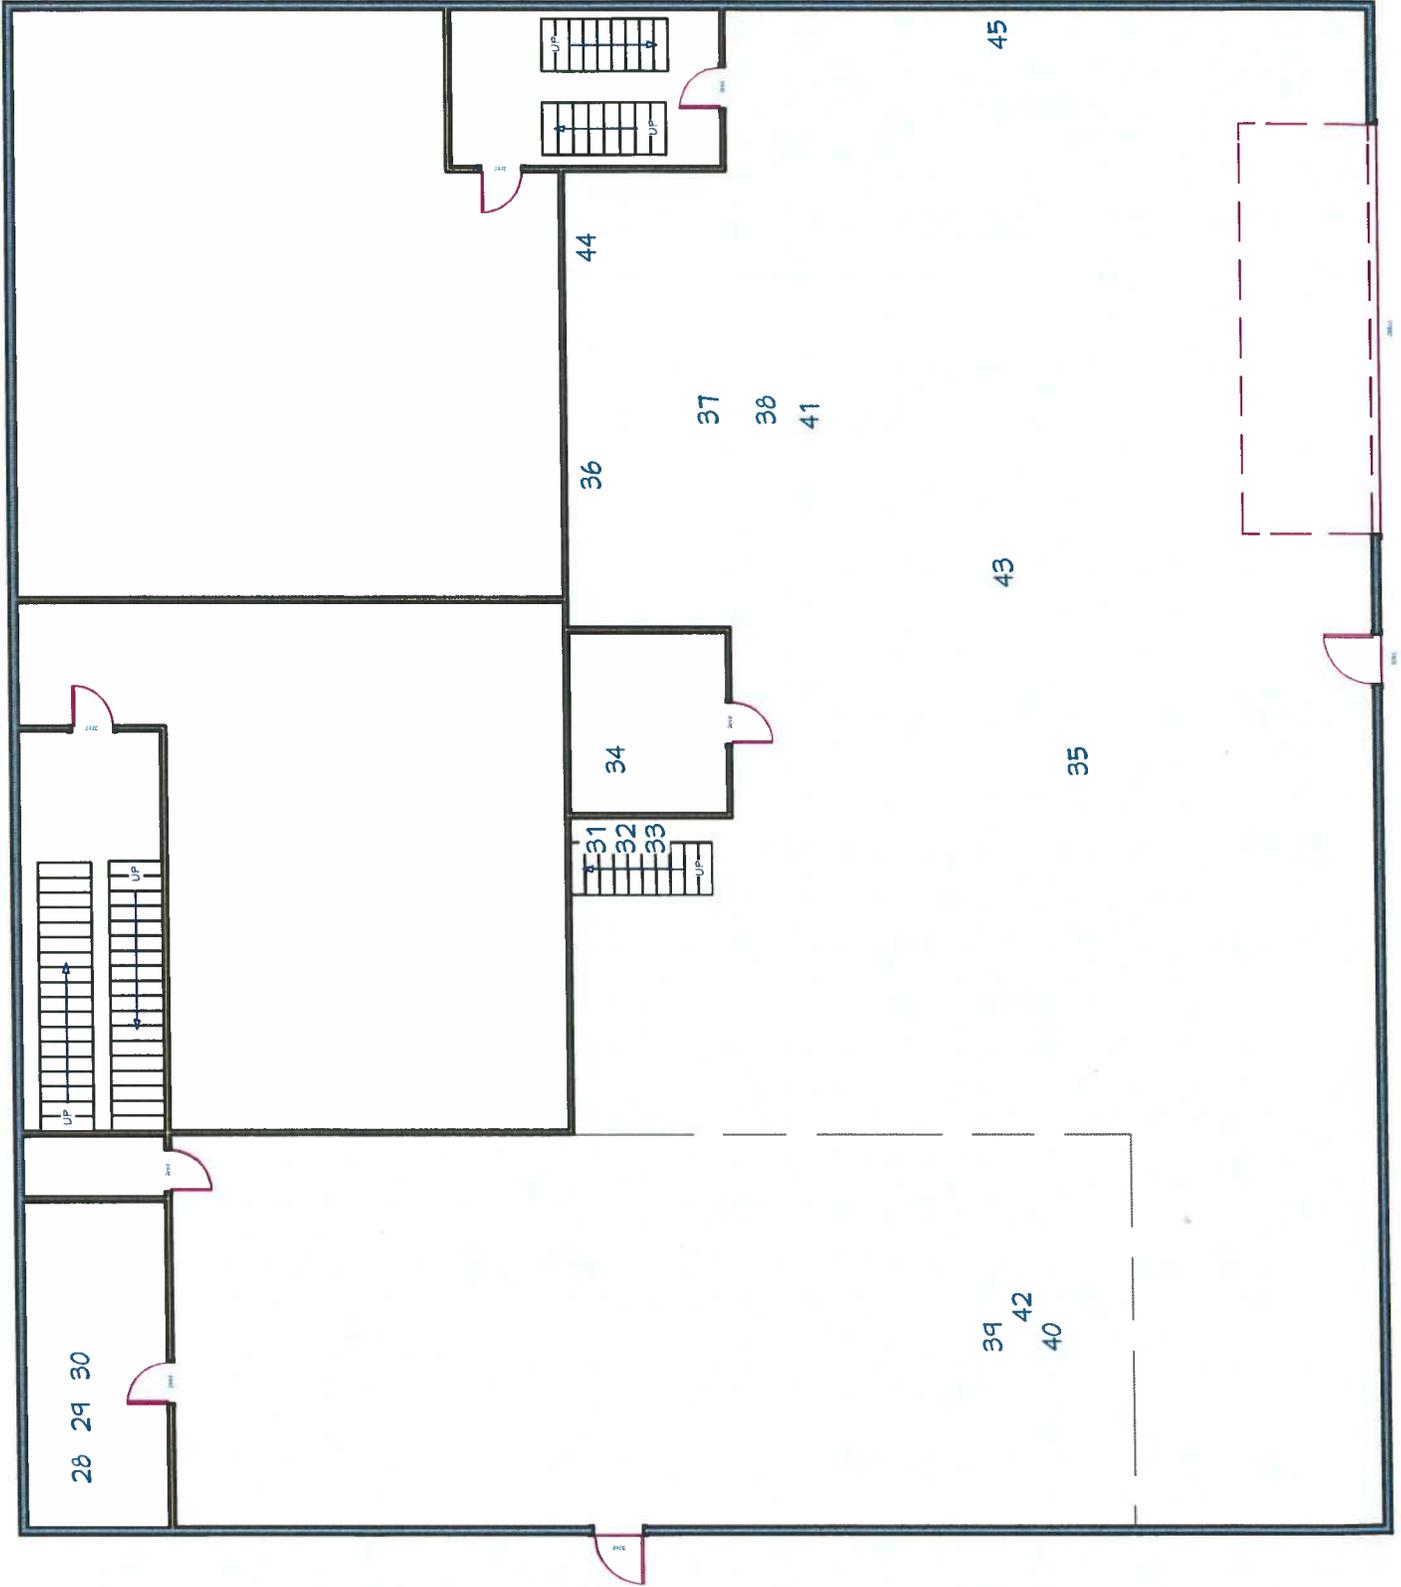
Mingo Junction Steel Maintenance Building Basement

SAMPLE	LOCATION	DESCRIPTION	APPROX QUANTITY	CONDITION	POTENTIAL FOR DAMAGE	ASBESTOS CONTENT
32	Maintenance Building Basement Orange Painted 4" Labeled Non-Asbestos	Orange / Black Tar Paper / Insulation	210 Ln Ft Visible (L)	Poor	High	15 %
33	Maintenance Building Basement Orange Painted 4" Labeled Non-Asbestos	Orange Insulation	210 Ln Ft (M)	Poor	High	None
34	Maintenance Building Basement Orange Painted 8" Not Labeled	Orange / White Insulation	80 Ln ft Visible (N)	Poor	High	55 %
35	Maintenance Building Basement Orange Painted 8" Not Labeled	Orange / White Insulation	(N)	Poor	High	55 %
36	Maintenance Building Basement Orange Painted 8" Not Labeled	Orange / White Insulation	(N)	Poor	High	55 %
37	Maintenance Building Basement Orange Painted 4" Labeled Non-Asbestos	Orange / Yellow Insulation	(K)	Poor	High	25 %
38	Maintenance Building Basement Orange Painted 4" Labeled Non-Asbestos	Orange / Yellow Insulation	(L)	Poor	High	20 %

SAMPLE	LOCATION	DESCRIPTION	APPROX QUANTITY	CONDITION	POTENTIAL FOR DAMAGE	ASBESTOS CONTENT
41	Maintenance Building Basement Orange Painted 4" Labeled Asbestos	Orange / White Insulation	(M)	Poor	High	55 %
42	Maintenance Building Basement Orange Painted 4" Labeled Asbestos	Orange / White Insulation	(M)	Poor	High	55 %
43	Maintenance Building Basement 4" Not Painted or Labeled	Black / White Insulation	270 Ln Ft Visible (N)	Poor	High	None
44	Maintenance Building Basement 4" Not Painted or Labeled	Black / White Insulation	(N)	Poor	High	None
45	Maintenance Building Basement 4" Not Painted or Labeled	Black / White Insulation	(N)	Poor	High	None
46	Maintenance Building Roof Larger Area	Brown Roofing	5,100 Sq Ft (O)	Poor	High	None
47	Maintenance Building Roof Larger Area	Brown Roofing	(O)	Poor	High	None
48	Maintenance Building Roof Larger Area	Brown Roofing	(O)	Poor	High	None
49	Maintenance Building Roof Smaller Center Area	Black / Yellow Roofing	3,100 Sq Ft (P)	Poor	High	None

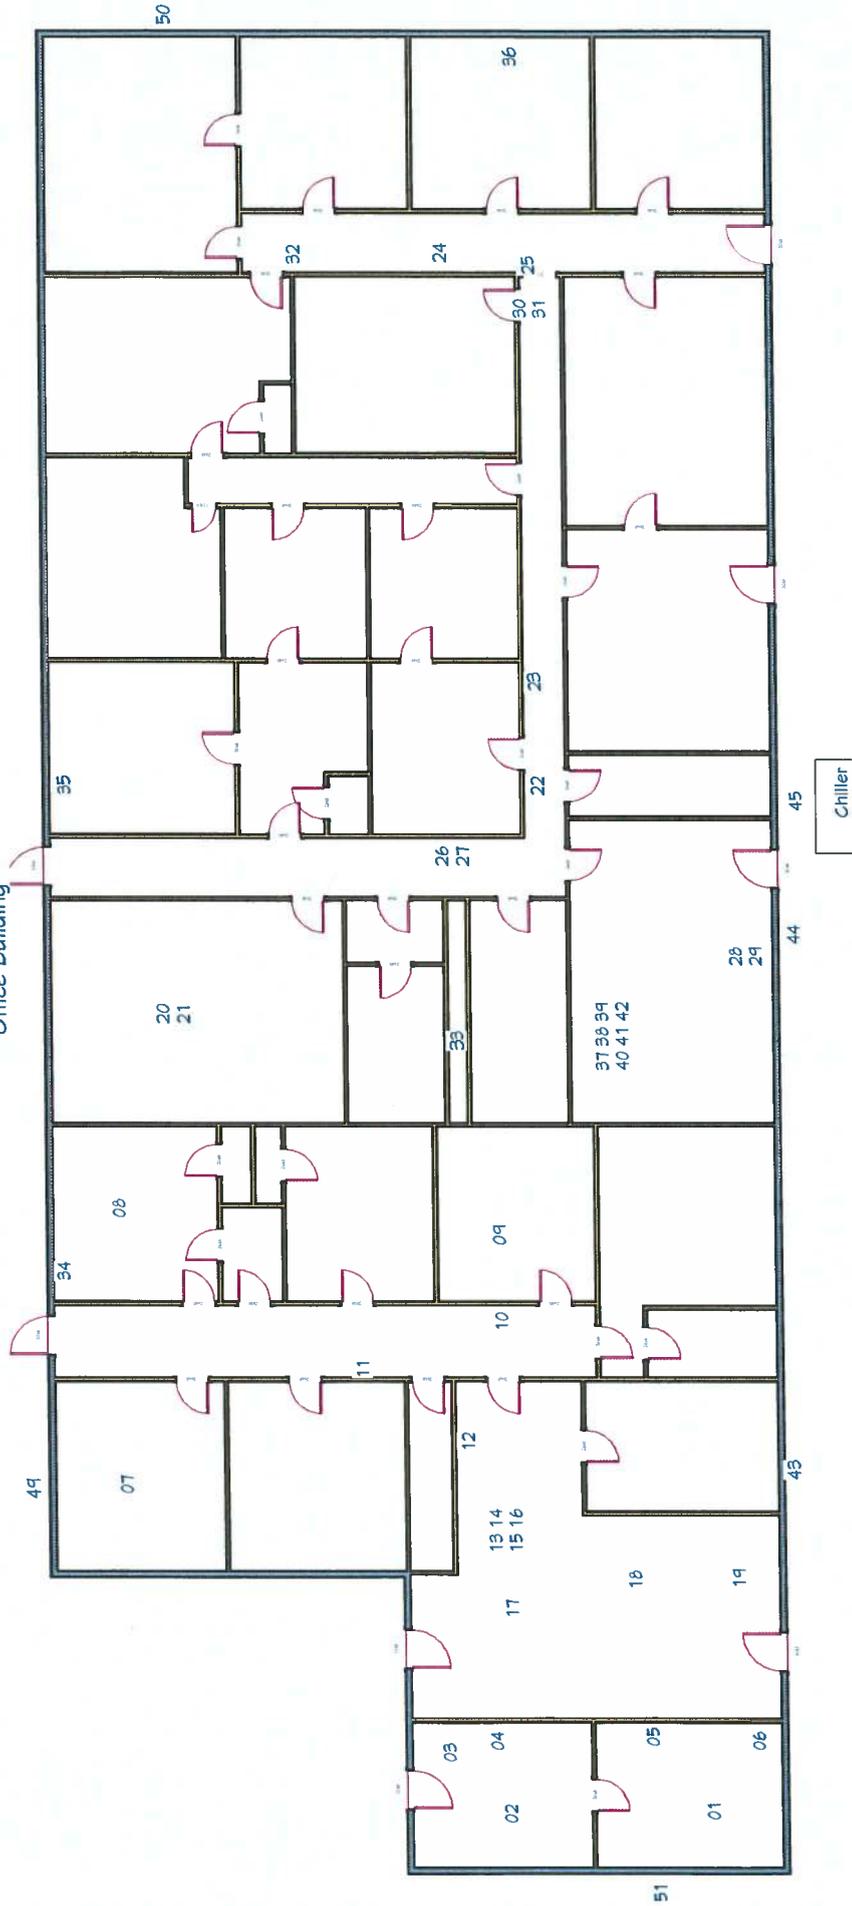
Mingo Junction Steel
Office Building

SAMPLE	LOCATION	DESCRIPTION	APPROX QUANTITY	CONDITION	POTENTIAL FOR DAMAGE	ASBESTOS CONTENT
09A	Office Building Throughout Some Under Carpet	Grey 12 x 12 Floor Tile	(C)	Poor	High	3 %
09B	Office Building Throughout Some Under Carpet	Black Floor Tile Mastic	(C)	Poor	High	5 %
10A	Office Building Throughout	Black 4" Cove Base	(D)	Poor	High	None
10B	Office Building Throughout	Brown Cove Base Adhesive	(D)	Poor	High	None
11	Office Building Throughout	Grey / Brown Drywall	(E)	Poor	High	None
12	Office Building Throughout	Off White Joint Compound	Unknown	Poor	High	Trace
13A	Office Building Throughout 4" Water Lines Above Ceiling	Black Tar Paper	270 Ln Ft Visible (F)	Poor	High	20 %
13B	Office Building Throughout 4" Water Lines Above Ceiling	Grey Mag. Insulation	(F)	Poor	High	20 %
14A	Office Building Throughout 4" Water Lines Above Ceiling	Black Tar Paper	390 Ln Ft Visible (G)	Poor	High	20 %
14B	Office Building Throughout 4" Water Lines Above Ceiling	Grey Mag. Insulation	(G)	Poor	High	20 %

SAMPLE	LOCATION	DESCRIPTION	APPROX QUANTITY	CONDITION	POTENTIAL FOR DAMAGE	ASBESTOS CONTENT
15	Office Building Throughout 4" Water Lines Above Ceiling	Grey Fitting Mud	30 Fittings Visible (H)	Poor	High	5%
16	Office Building Throughout 4" Water Lines Above Ceiling	Grey Fitting Mud	15 Fittings Visible (I)	Poor	High	5%
17	Office Building Security Office Above Ceilings	Yellow / White / Silver TSI Fiberglass	30 Ln Ft (J)	Poor	High	None
18	Office Building Security Office Above Ceilings	Yellow / White / Silver TSI Fiberglass	(J)	Poor	High	None
19	Office Building Security Office Above Ceilings	Yellow / White / Silver TSI Fiberglass	(J)	Poor	High	None
20	Office Building Throughout	Brown / White 2 x 4 Ceiling Tile	(A)	Poor	High	None
21	Office Building Throughout Above Ceiling Tile	Brown / Green Fiberglass Insulation	(B)	Poor	High	None
22A	Office Building Throughout Some Under Carpet	Grey 12 x 12 Floor Tile	(C)	Poor	High	2%
